# **BULLETIN**

**No. 113**  
June 2018

**ANNULAR SPACE PROTECTION OF OPENINGS CREATED BY PENETRATIONS  
OF TUBULAR STEEL CONDUIT. A REVIEW OF UL SPECIAL SERVICES  
INVESTIGATION FILE NC546 PROJECT 90NK11650**

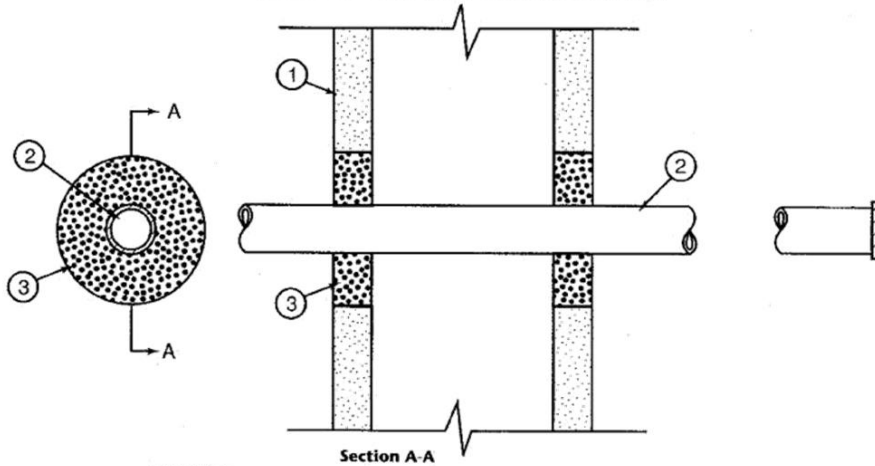
**EXAMPLE OF PENETRATION OF 4 HR. CONCRETE BLOCK WALL**  
**TEST ASSEMBLY NO. 1/TEST CONFIGURATION NO. 4**

Item no.	Description
1	Nom. 8" thick Concrete Block Wall.
2	Nom. 1/2" Rigid Conduit centered in Nom. 4" opening. Conduit extended 12" & 36" beyond the exposed & unexposed surfaces, respectively. Nom. 1/8" thick steel plate welded to exposed end of conduit.
3	Nom. 2 1/8" Thickness of type M mortar installed within the annular space of both faces of block, flush with each surface of wall.

TEST ASSEMBLY #1—4 HOUR FIRE EXPOSURE PERIOD  
 CONCRETE BLOCK WALL

Test Configuration No.	Opening Size	Penetrating Item(s)	Annular Space Protection Material(s)	Fire Exposure Results
1	Nominal 8 in. diameter	Nominal 4 in. diameter EMT	Nominal 2-1/8 in. thickness of Type M mortar on each side of wall.	Pass
2	Nominal 8 in. diameter	Nominal 4 in. diameter rigid conduit	Nominal 2-1/8 in. thickness of Type M mortar on each side of wall.	Pass
3	Nominal 6 in. diameter	Nominal 2 in. diameter EMT	Nominal 2-1/8 in. thickness of Type M mortar on each side of wall.	Pass
4	Nominal 4 in. diameter	Nominal 1/2 in. diameter rigid conduit	Nominal 2-1/8 in. thickness of Type M mortar on each side of wall.	Pass
5	Nominal 4 in. diameter	Nominal 1/2 in. diameter EMT	Nominal 2-1/8 in. thickness of Type M mortar on each side of wall.	Pass
6	Nominal 6 in. high by 10-1/2 in. wide	Nominal 1/2, 3/4, 1-1/2, 2 and 4 in. diameter EMT, spaced 3/4 in. apart	Nominal 2-1/8 in. thickness of Type M mortar on each side of wall.	Pass

The concrete block wall consisted of a 54 in. wide by 66 in. high wall constructed with nominal 8 in. thick concrete blocks having a 4 hour fire endurance rating when tested in accordance with the Standard “Fire Tests of Building Construction and Materials”, ANSI/UL 263 (ASTM E119). The blocks were assembled using Type M mortar.
